Briefing on Bay Bridge Bolts – July 10, 2013

THE SAN FRANCISCO-OAKLAND
BAY BRIDGE
SEISMIC SAFETY PROJECT

2008 Rods Failed Due to Hydrogen Embrittlement

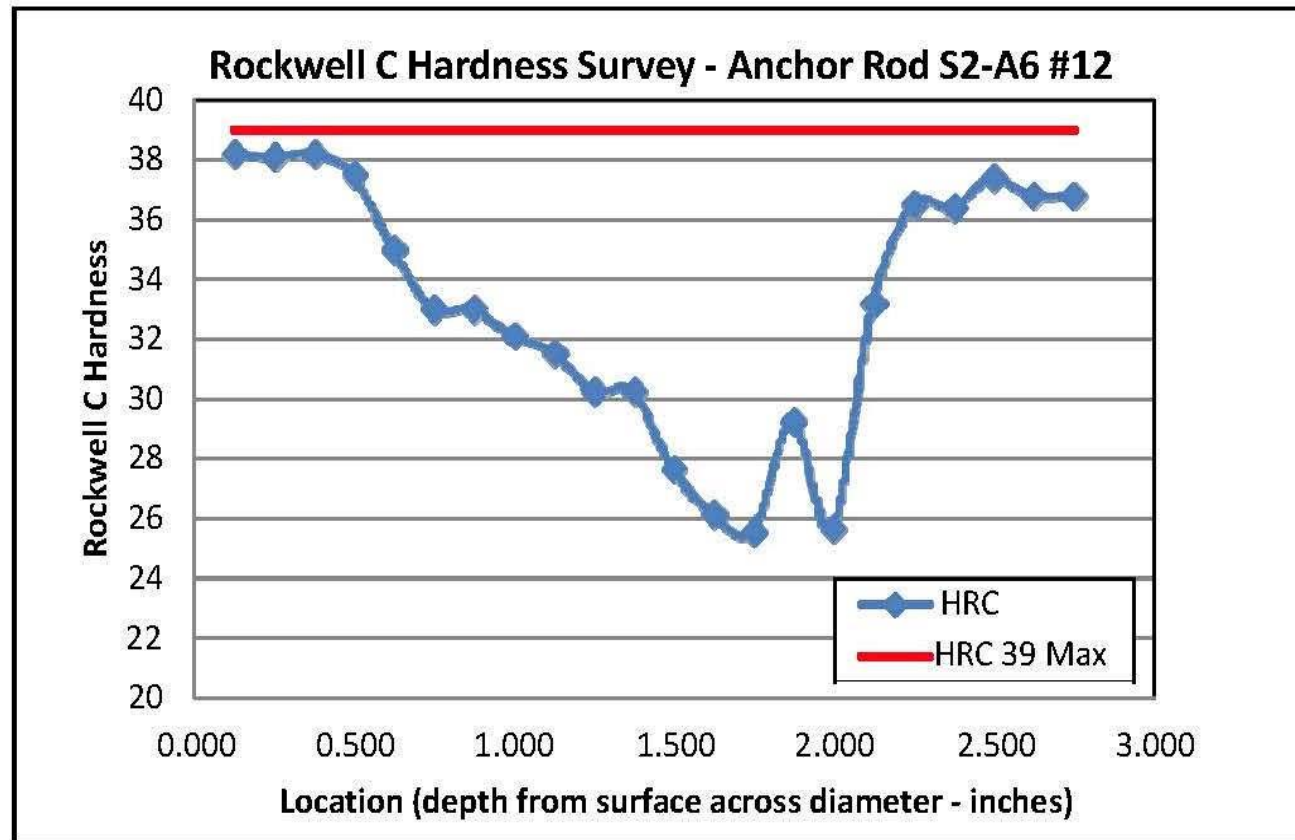
- Rods exhibited a material susceptibility to hydrogen embrittlement with a heterogenous structure and high surface hardness.

- Per the joint metallurgical report, 2008 rods had “...higher than normal susceptibility of the steel to hydrogen embrittlement,” but complied with specifications selected by the designer and owner of project
- Embedded rod design did not adequately address drainage, while contractor did not adequately provide on-site protection of 2008 rods from the environment during construction

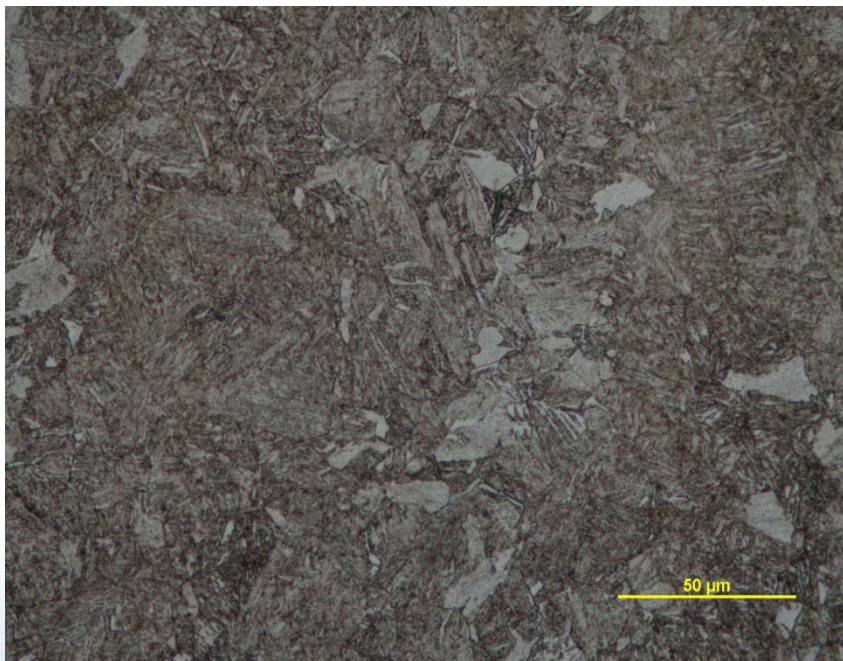
Failed 2008 Rod

Structure is not fully tempered martensite.
The center region did not fully transformed
into martensite

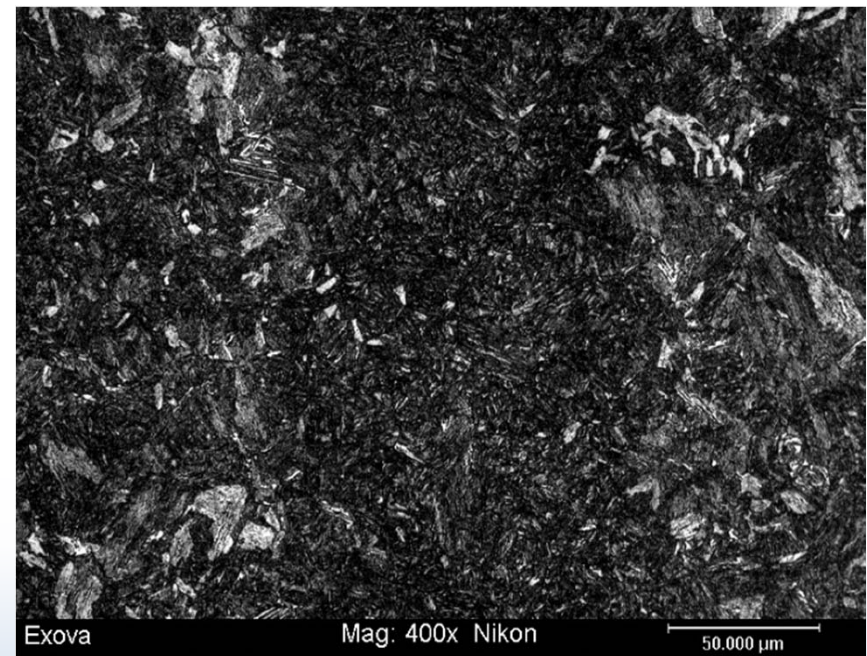
Other Rod

Essentially martensitic structure.

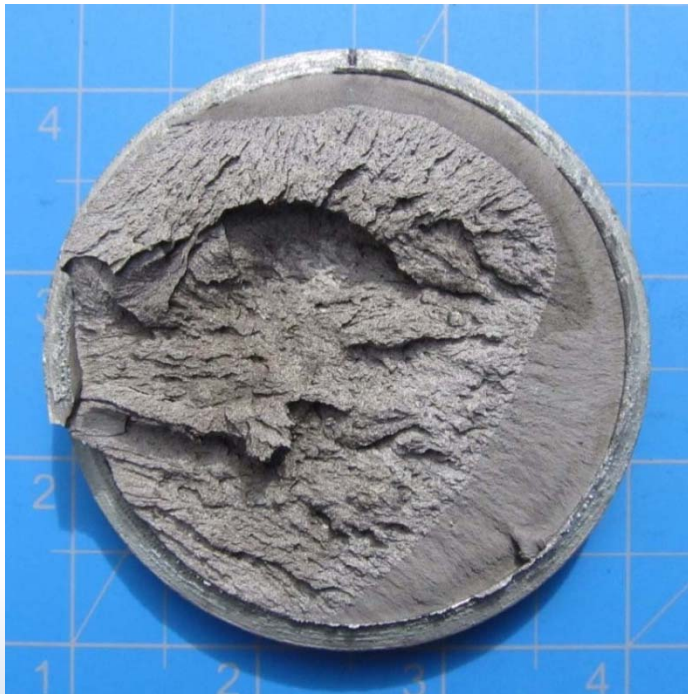
Failed 2008 Rod

Brittle Failure in Field

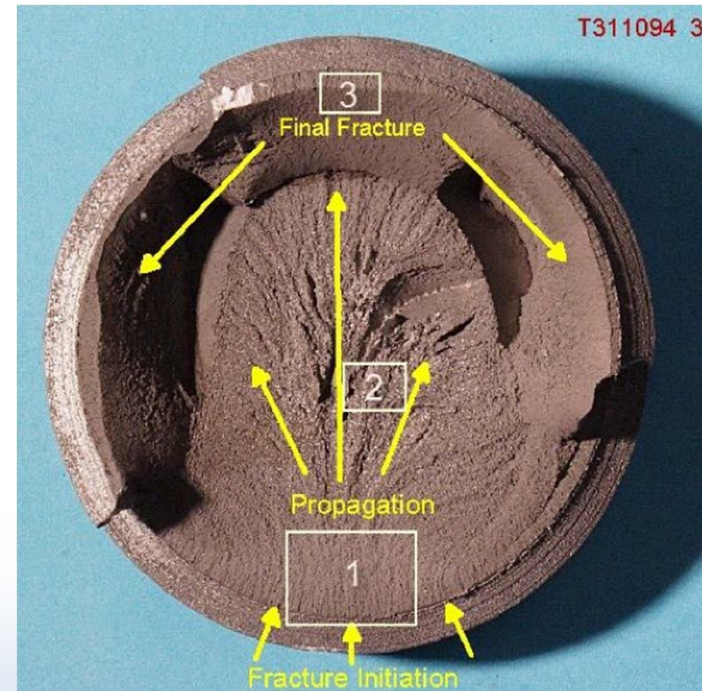
Other Rod

Ductile Failure in Lab Test
